# **The Long Term Performance of Three Ontario Bridges Constructed with Galvanized Reinforcement**

This report summarizes the results of a research program undertaken by the Ontario Ministry of Transportation to assess the corrosion protection provided by galvanized reinforcement. Three Ontario structures were studied, built in 1975 and 1976 using galvanized reinforcement and construction practices typical of the time period. The investigation included periodic visual surveys of the structures as well as measurement of corrosion potentials, corrosion currents and degree of delamination of the concrete. Concrete quality and chloride content were also assessed. Findings of the evaluation indicate that the long-term (30-year) performance of galvanized reinforcement, while marginally better than that of conventional black reinforcement, showed evidence of corrosion and resulting delamination of the concrete when the chloride content of the concrete exceeded the threshold to initiate corrosion. On one structure approximately 10% of the deck had deteriorated and required rehabilitation before achieving even a twenty-year service life. Based on the structures surveyed, galvanized reinfor

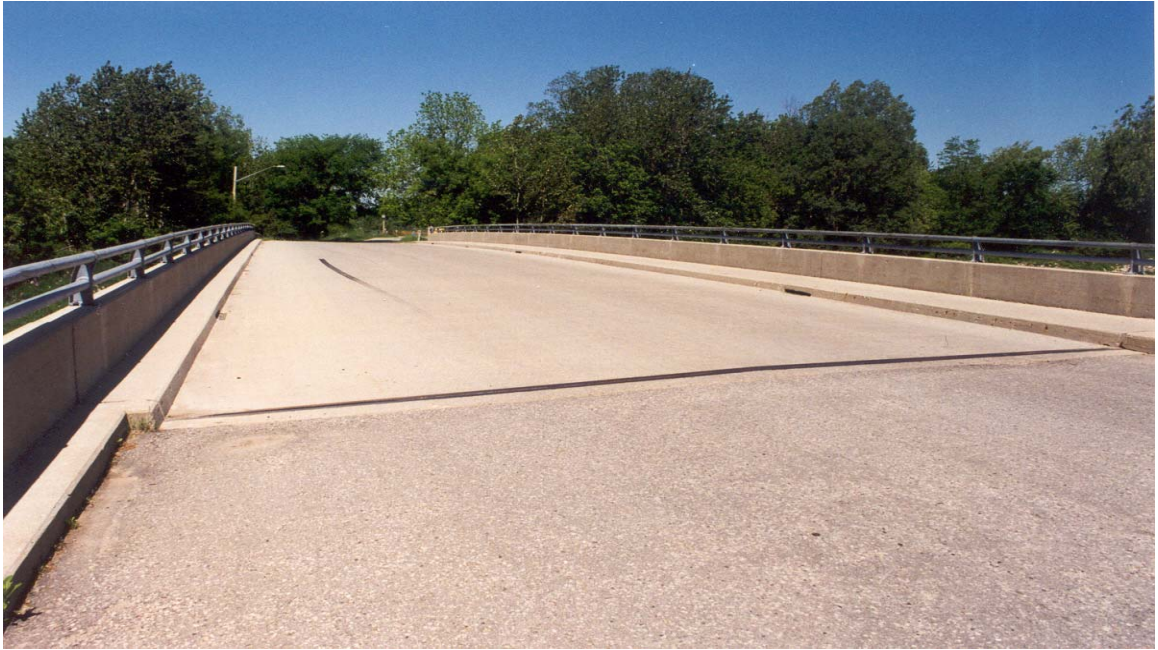
**Figure 1 General View Victoria Street Bridge**

The Victoria Street Bridge in Wingham, Ontario, was built by Huron County in 1975 and is located in a rural environment. The deck is a post-tensioned, 3 span continuous thick slab design. The concrete deck measures approximately 52 metres by 10 metres. All the reinforcing steel was galvanized but not chromate treated. The structure is shown in Figure 1.

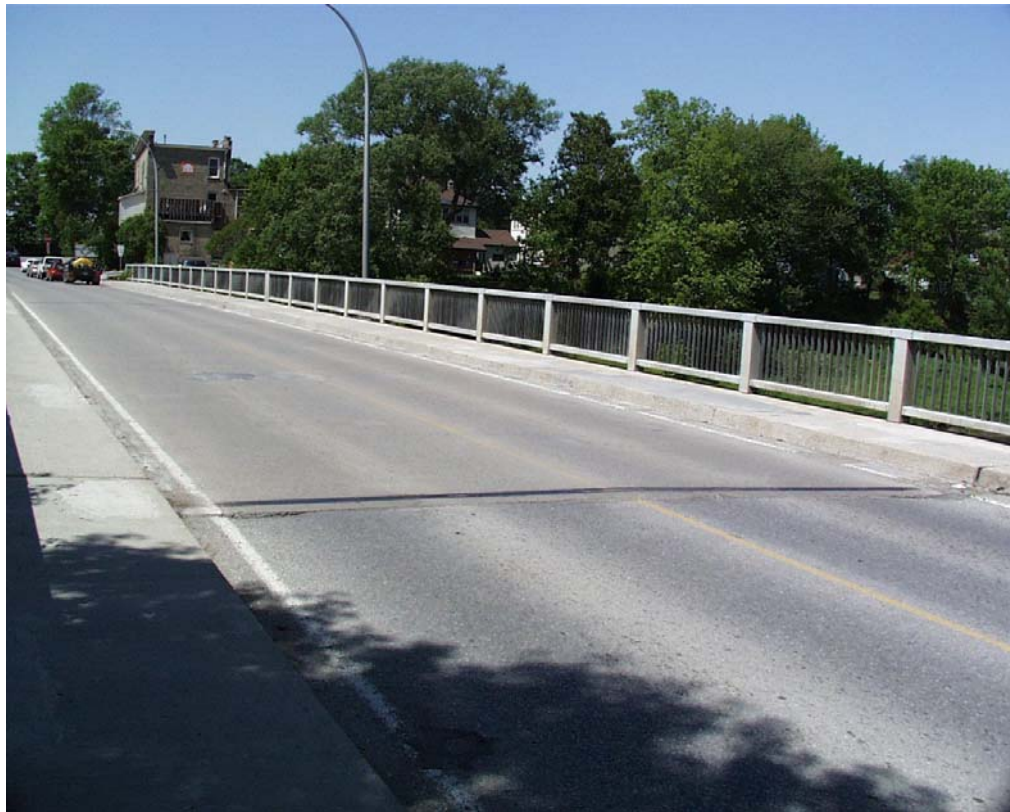
The Dorchester Bridge was originally built in the 1920's, carrying Bridge Street over the south branch of the Thames River. This rural bridge has four simply supported main spans. In 1976 the deck was replaced with supporting stringers and beams strengthened to accommodate a wider deck utilizing galvanized reinforcing steel. The deck surface is exposed concrete and is approximately 44 metres long and 7 metres wide. (Figure 2).

**Figure 2 General View Bridge Street Bridge**

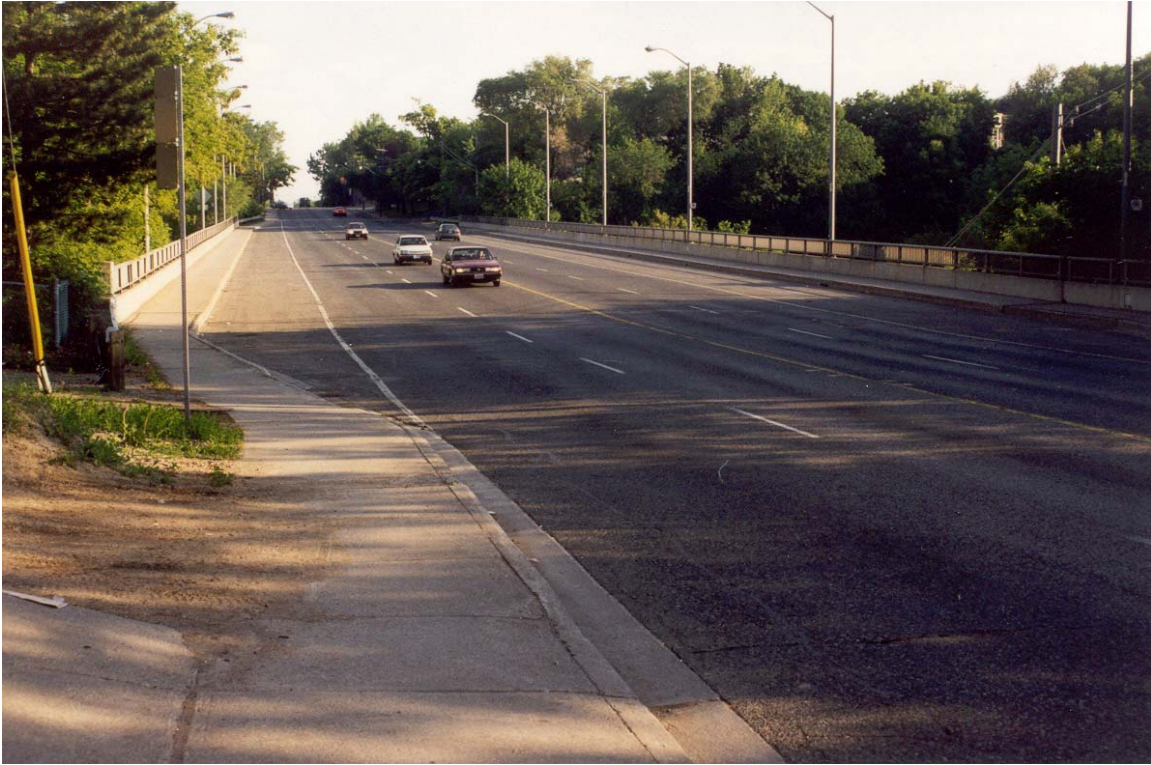
The Bathurst Street Bridge is an four-span 143 metre long concrete reinforced deck on prestressed concrete girders, in an urban setting. The bridge is located in the city of Toronto and has an over all width of 26 metres. The bridge was built in 1975 using galvanized reinforcement in the deck, sidewalk, and barrier wall. The deck was waterproofed at the time of construction with a rubberized asphalt membrane overlaid with bituminous wearing surface. Figure 3.

**Figure 3 General View Bathurst Street Bridge**

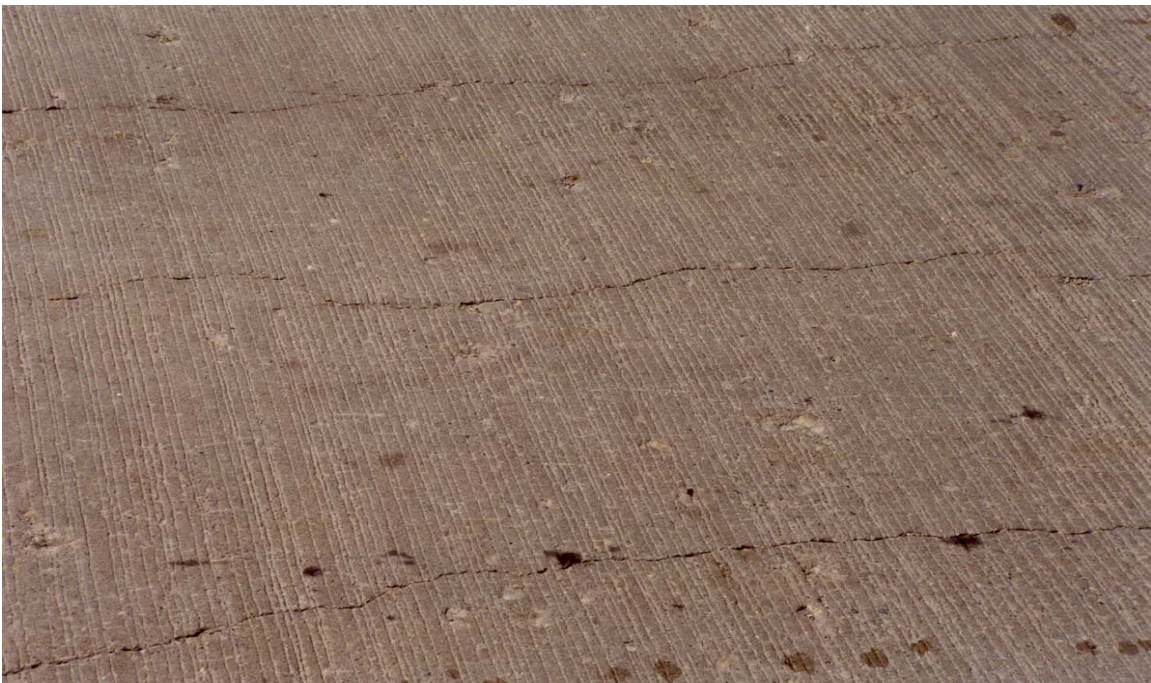
**Figure 4 Victoria Street Bridge Showing Cracks in Concrete Deck (1998)**

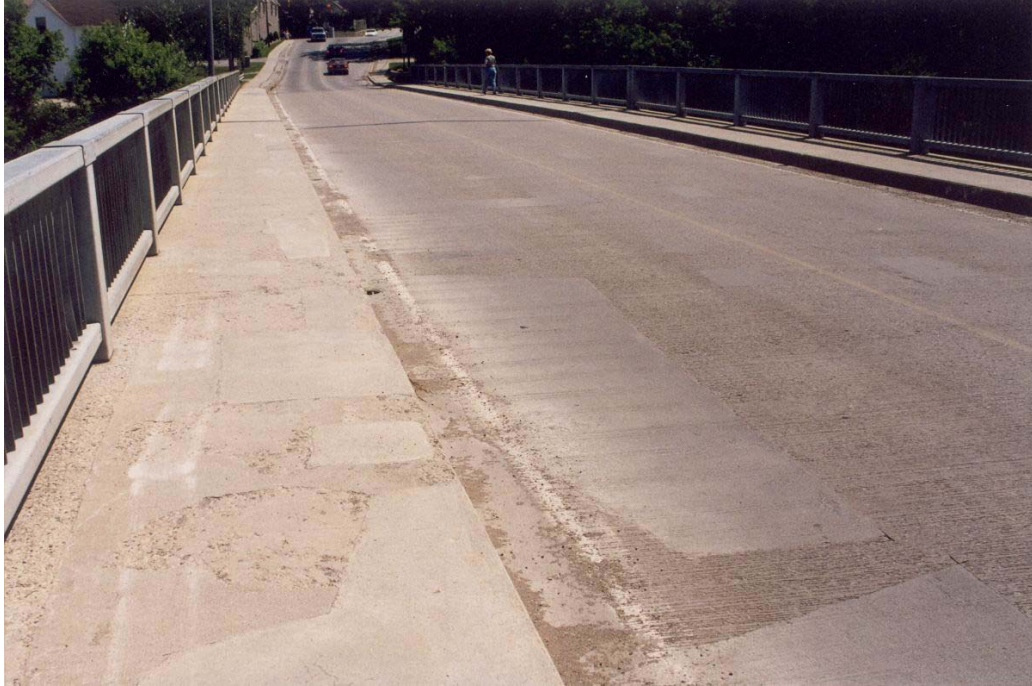
A condition survey of the Dorchester Bridge was conducted by the consulting firm M.M. Dillon Limited in July 1994 and reported in <sup>(11)</sup>. The surface of the deck was sounded to locate areas of delamination, and visible defects such as patches were also recorded. Eighteen years after construction, the exposed concrete deck was described by the firm as “in fair condition with numerous areas of delaminations and a few spalls. Several areas of the deck had been previously patched with cementitious and asphaltic materials” (Figure 5).

**Figure 5 Bridge Street Showing Extensive Patches in Deck and Sidewalk**

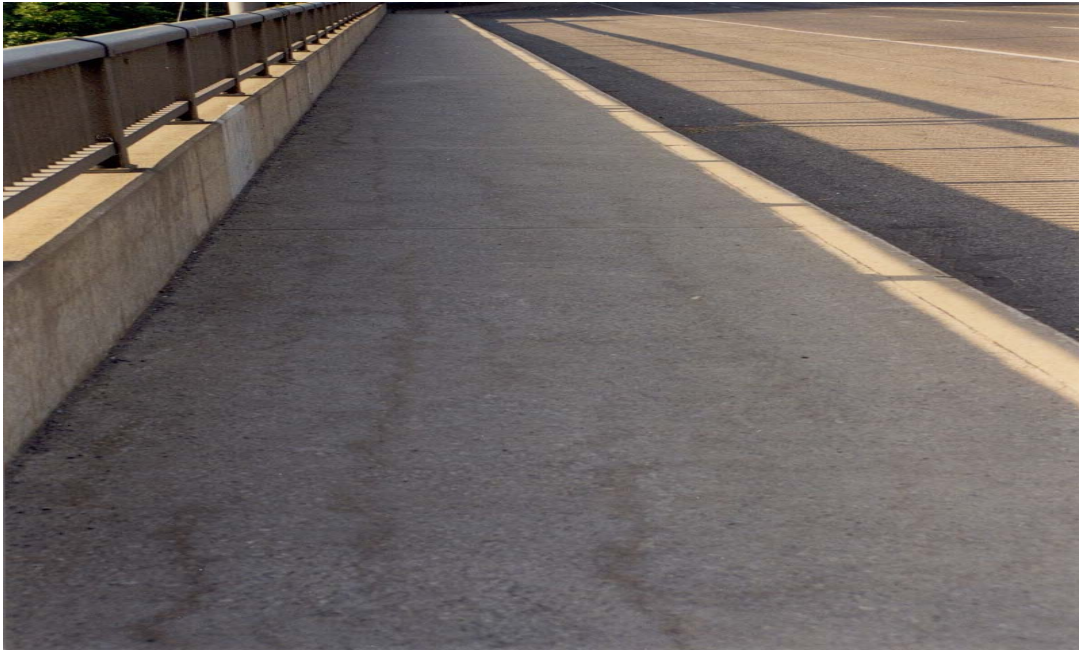
In 1995 the east and west sidewalks were found to be in fair condition with numerous narrow to wide longitudinal cracks and several medium to wide transverse cracks present. Rust stains were evident along the longitudinal cracks at several locations corresponding to the position of the top transverse reinforcement (Figure 6).

**Figure 6 Bathurst Street Showing Cracks and Staining in East Sidewalks**

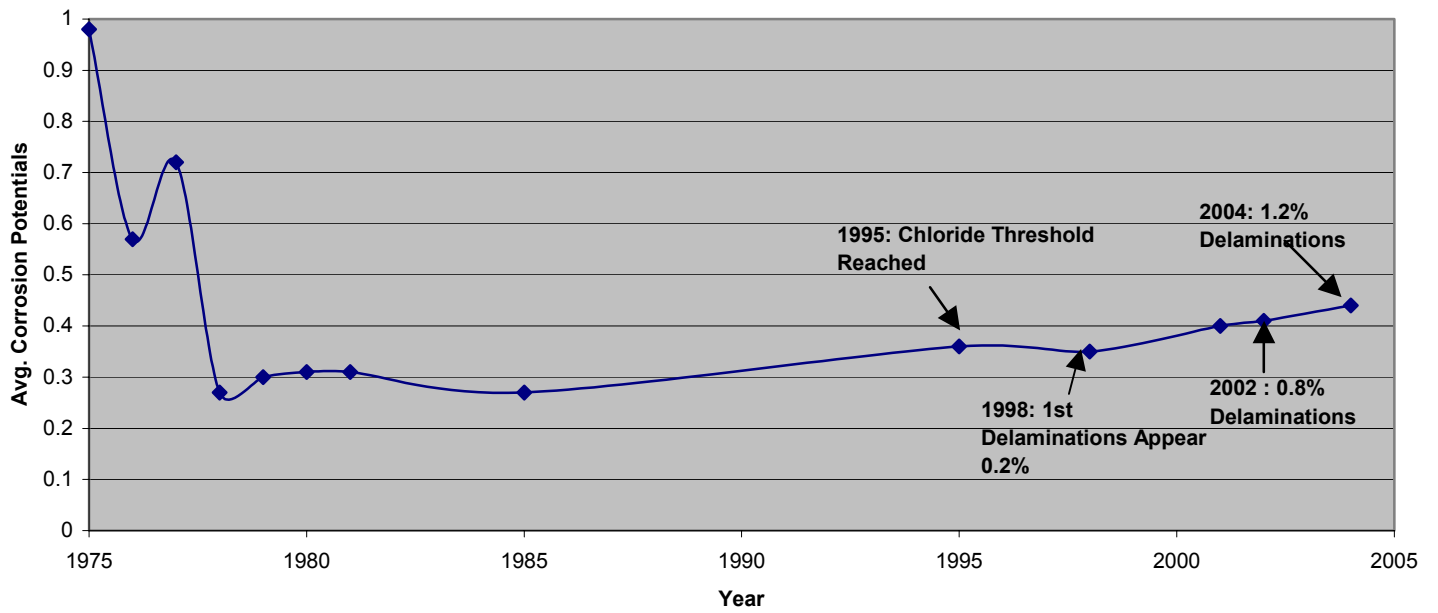
### Figure 7 Victoria Street Bridge - Wingham Average Corrosion Potentials

Initially the average corrosion potentials measured were approximately – 1.0 volt. This potential slowly increased to – 0.27 volts and remained there for approximately ten years after construction. This value represents a passive corrosion potential for galvanized reinforcement embedded in concrete. After this passive potential was reached in 1985 the potential slowly decreased during the following 19 years indicating a loss of passivity.

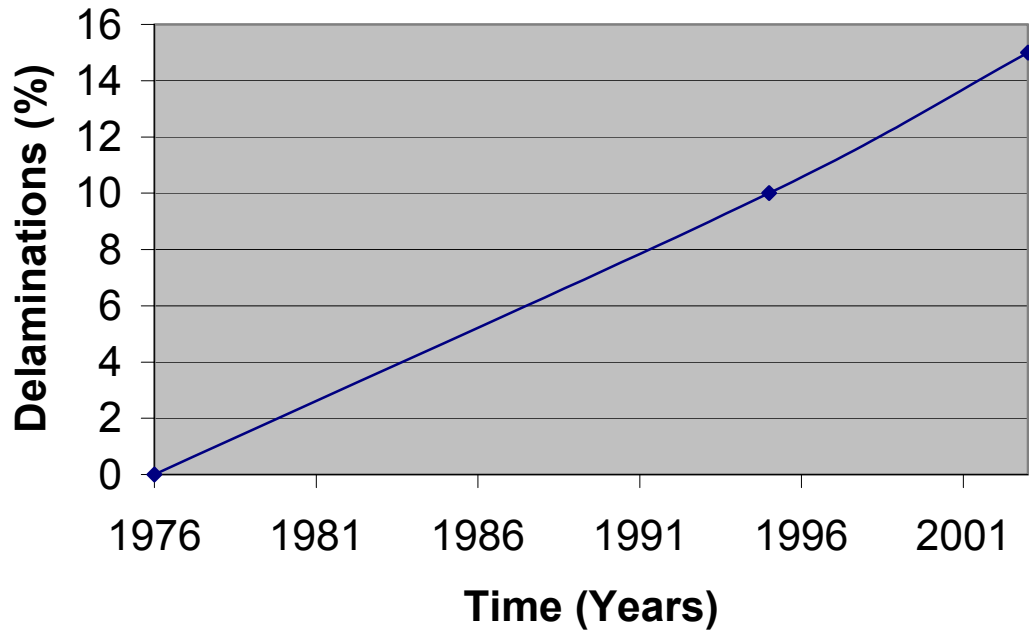
**Figure 9 Progression of Delaminations  
Dorchester Bridge**

In 2003, MTO again conducted a condition on the bridge. The survey indicated that approximately 15% of the deck surface was delaminated or had already received a repaired treatment, an increase of 5% since the condition survey was conducted in 1995. The average half-cell potential on the deck was  $-0.47\text{v}$ . Essentially all (99.6%) of the potential readings were more negative than  $-0.35\text{v}$ . The potentials ranged from  $-0.35$  to  $-0.69\text{v}$ .

Of the three bridges investigated the Dorchester Bridge demonstrated the highest level of corrosion activity and related deterioration. In 1995, 19 years after construction, approximately 10% of the deck had showed deterioration due to corrosion or had already received rehabilitation. The chloride ion content at the level of the reinforcement had reached approximately three times the threshold necessary to initiate corrosion. It is not clear when the chloride threshold reached the reinforcement so the service life extension provided by the galvanized reinforcement cannot be accurately established. During the period from 1995 to 2003 delaminations increased from 10% to 15% of the deck surface area. For comparison, a bridge deck under MTO jurisdiction would be a candidate for bridge deck rehabilitation once the amount of delamination exceeded 10% of the deck area, typically receiving a concrete overlay. The growth rate of the delaminations 1995-2003 appear to be less than what would be expected for black steel reinforcement.
